CUTTING WEDGE WEAR EXAMINATION DURING TURNING OF DUPLEX STAINLESS STEEL

Original scientific paper

Keywords: Duplex Stainless Steel (DSS), machining, turning, surface layer, tool wear

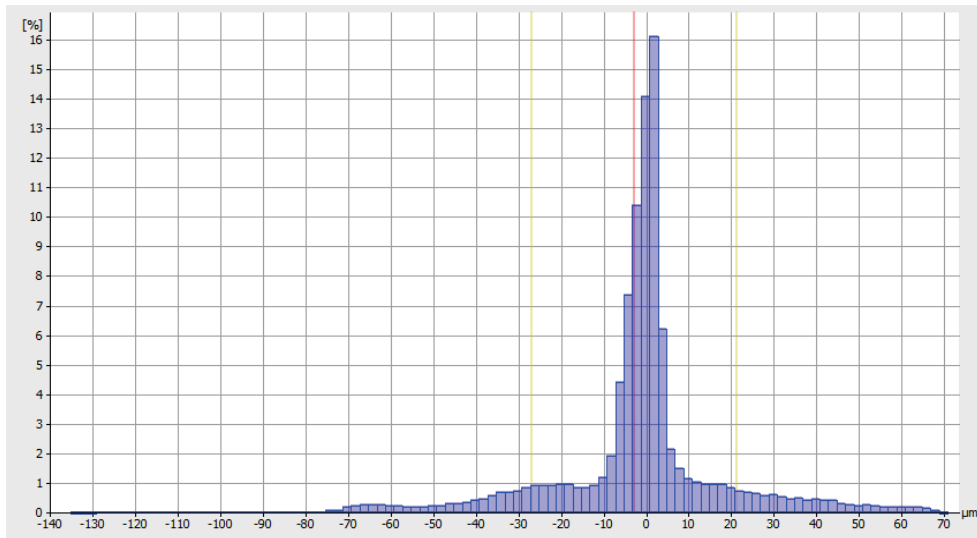
Figure 3 Deviation values tool wear histogram during turning of DSS for $v_c = 150$ m/min

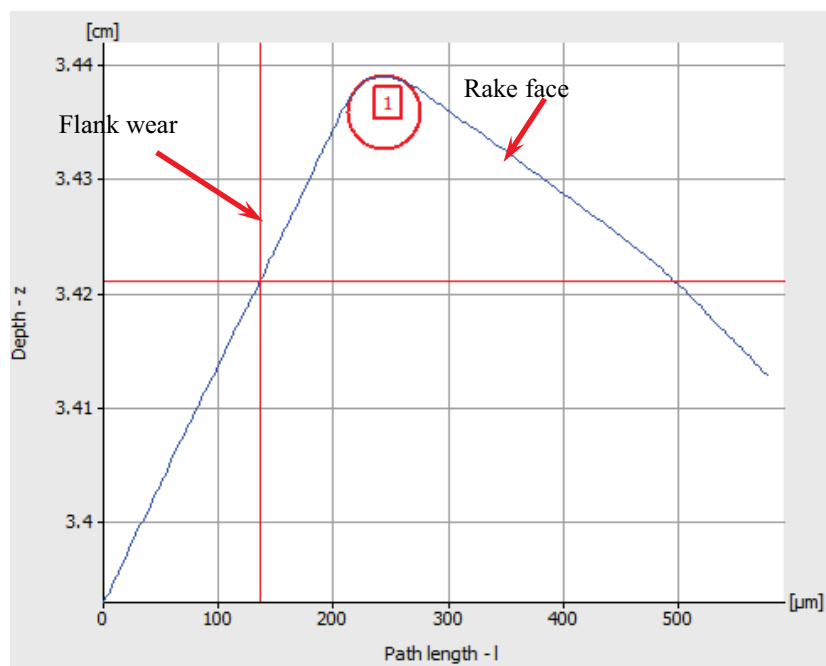
Figure 4 Extracted profile of cutting wedge during turning of DSS for $v_c = 150$ m/min

Fig. 4 shows an extracted cutting wedge profile together with matched geometry. The cutting plate acc. to PN-ISO 1832:1998 [8] is designated E (E – rounded shape). Therefore it has the cutting edge radius r_n .

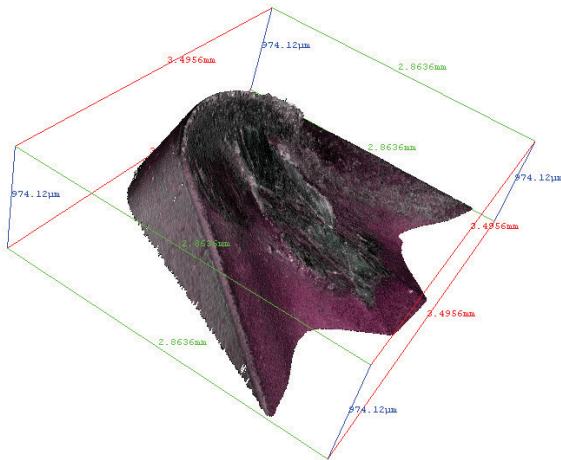
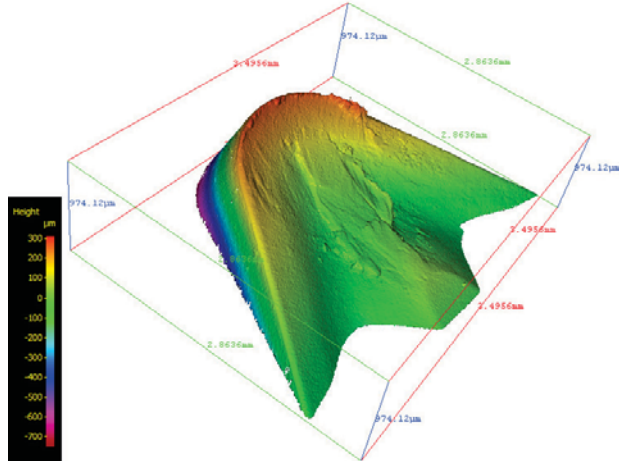
The cutting wedge surface topography after turning duplex steel at the cutting speed of 50 m/min is shown in Fig. 5. The built-up edge on the rake face is located as in the case of the wedge working at the cutting speed of 150 m/min, next to the main cutting edge, but with significantly smaller dimensions. One can also see the place of chip friction between the main cutting edge and the chip breaker together with a small built-up edge.

a) Rake face of the tool point W1 in real colour ($v_c = 50$ m/min, $f = 0,3$ mm/rev, $a_p = 2$ mm, dry)

b) Rake face of the tool point W1 in pseudo colour ($v_c = 50$ m/min, $f = 0,3$ mm/rev, $a_p = 2$ mm, dry)

Figure 5 Topography of W1 wedge wear during turning of DSS steel for $v_c = 50$ m/min

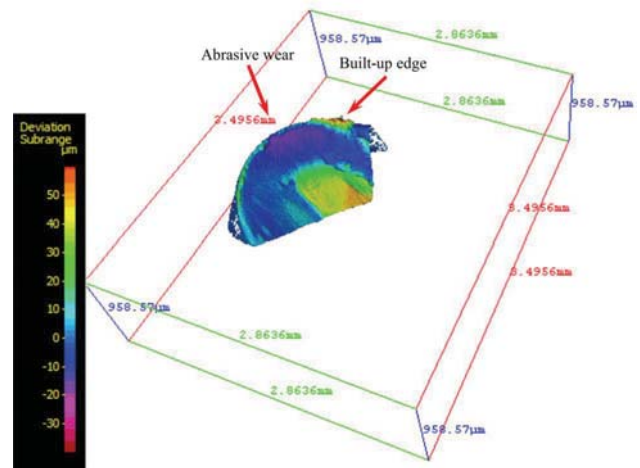
In order to find the dimensional differences between a wedge working at the cutting speed of 50 m/min and an unworn one, two digital images of the wear form of the cutting edges were compared. The result of the comparison of the cutting wedges is the built-up edge, dimensions shown in Fig. 6. One can see less intensive

formation of built-up edge next to the main cutting edge than in the case of the wedge working at the cutting speed of 150 m/min. During the operation of the wedge at the reduced speed, lowering of the cutting edge did not occur, but an abrasion wear land was found on the rake face at the location of chip friction.

Figure 6 Overlaid models of selection (region under investigation), deviations displayed in pseudo colours

The measurement results were as follows:

- mean deviation $-5,1034 \mu\text{m}$
- max. deviation $88,492 \mu\text{m}$
- min. deviation $-117,71 \mu\text{m}$.

Those results allow for the statement that the reduction of the cutting speed within the examined range of parameters of machining duplex steel results in a decrease of built-up edge on the rake face and eliminates lowering of the cutting edge. The mean deviation on the rake face of wedge no. 4 was $-5,1034 \mu\text{m}$ while, at the same time, in the case of a wedge working at the cutting speed of 150 m/min, the value was $-2,865 \mu\text{m}$. Fig. 7 shows a histogram of the distribution of vertices and upgrades on the cutting wedge. In the figure one can see even distribution in the part from -20 to about $15 \mu\text{m}$. Surface irregularities with the height of $40 \div 50 \mu\text{m}$ are about 2 % of the total number of irregularities. It can be seen that the cutting edge differs from the edge of the wedge working at the cutting speed of 150 m/min. Lowering of the cutting edge, on the other hand, has not been observed. Fig. 8 shows an extracted profile of a cutting wedge working at the speed of 50 m/min.

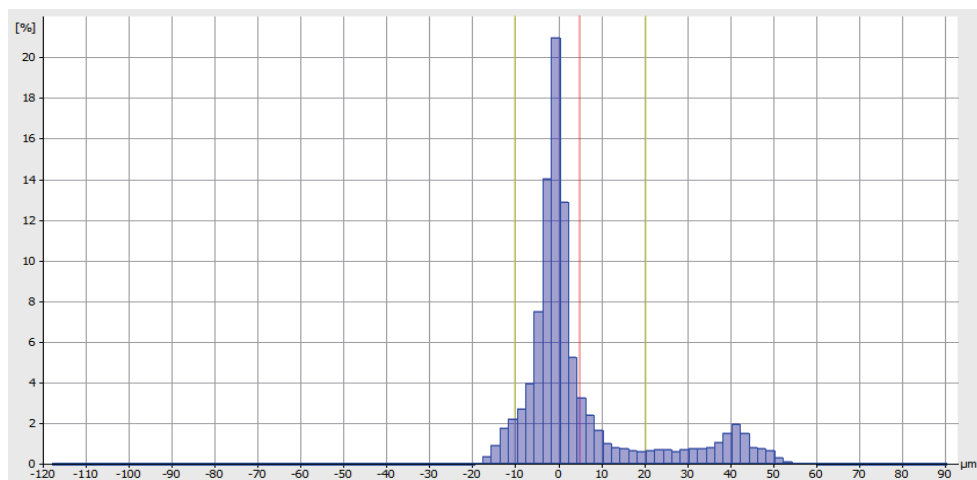
Figure 7 Deviation values tool wear histogram during turning of DSS for $v_c = 50$ m/min

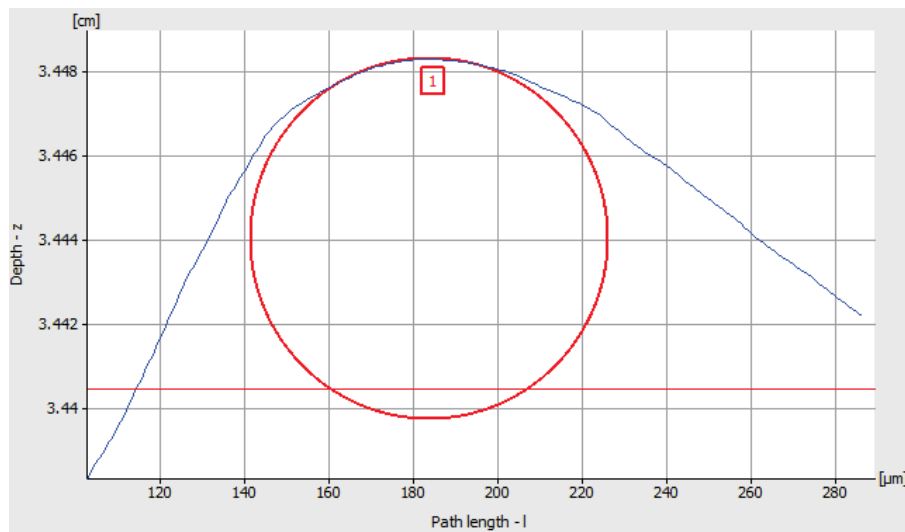
Based on the measurement of the geometry presented in Fig. 8, it was determined that the radius of the cutting

edge rounding r_n was $42,418 \mu\text{m}$. This confirms that machining of duplex stainless steel at higher speeds of the

order of 150 m/min causes lowering of the cutting edge, which is probably due to higher temperatures in the process of turning.

Figure 8 Extracted profile of cutting tool during turning of DSS for $v_c = 50$ m/min – zoomed in

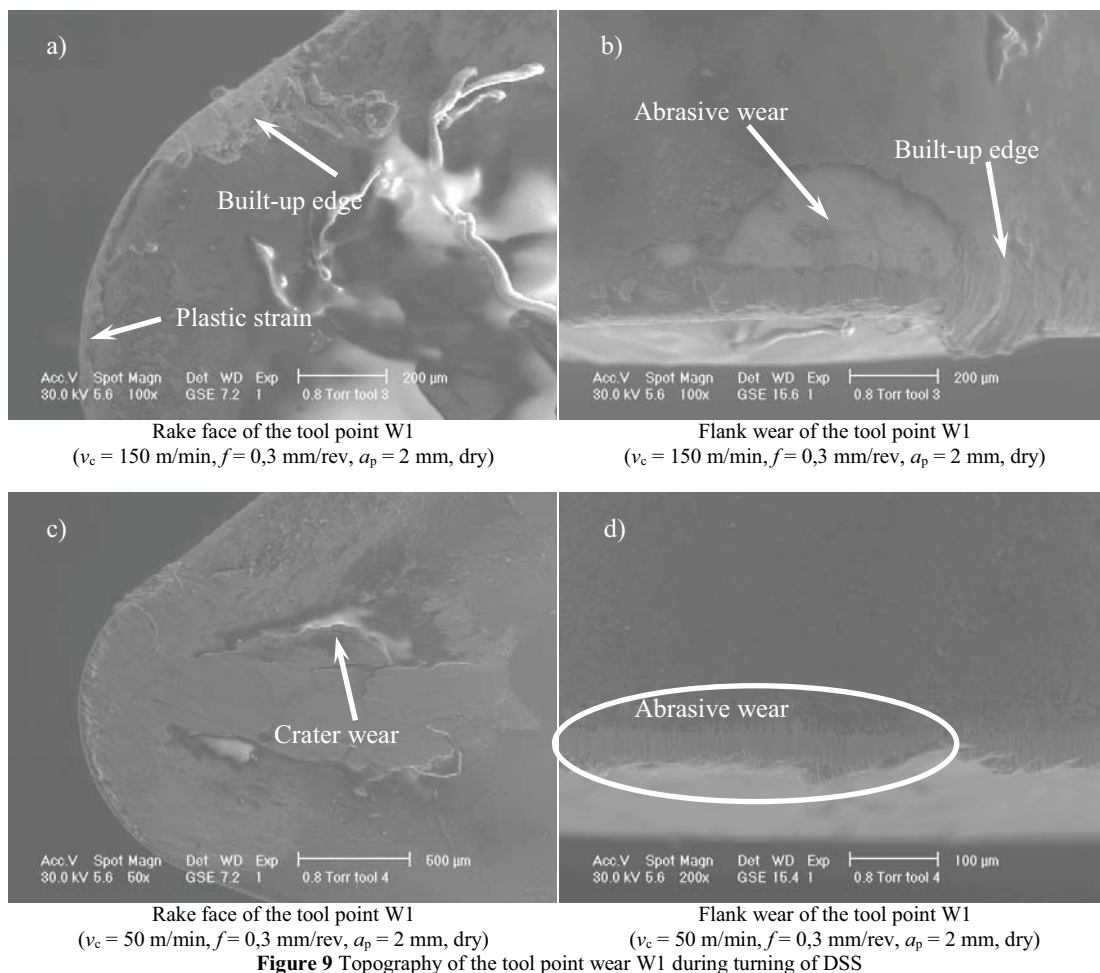
In this chapter, the condition of used tool point surfaces was assessed using the corresponding SEM images shown in Fig. 9. It should be noted that Figs. 9a and 9c represent SEM surface images of the rake face, while the Figs. 9b and 9d show the flank wear. It can be

concluded that in the process of sliding friction between surfaces some DSS particles were transferred to rake face near the tool point - chip contact zone. This phenomenon was documented in Fig. 9a. These particles in the form of a built-up edge are particularly visible on the rake face of the tool point with a cutting speed of 150 m/min. For this cutting speed a small plastic deformation on the rake face

and the built-up edge with the clash of the major flank can be observed (Fig. 9b). Reducing the cutting speed to 50 m/min resulted in crater wear appearing on the rake face (Fig. 9c) and the abrasive wear of the major flank (Fig. 9d).
